3D Mould break check

In sweets production, moulds of thermoplastic polymers are subjected to systematic wear and tear. Strong mechanical and thermal stresses lead to the moulds becoming brittle whereby parts can deform and break away. For inline recognition of **break-away pieces from the ridges on the backside**, and thus removing defective moulds directly from the process, Bi-Ber offers reliable 3D vision systems.

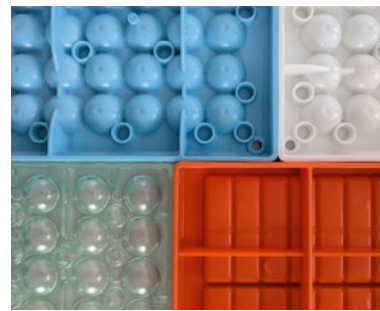
Various coloured sample moulds made of copolyester

The solution has already been **successfully tested with BPA-free moulds**. Therefore, the systems offer a high level of investment security even beyond 2027.
